# 321 BROGDON ROAD

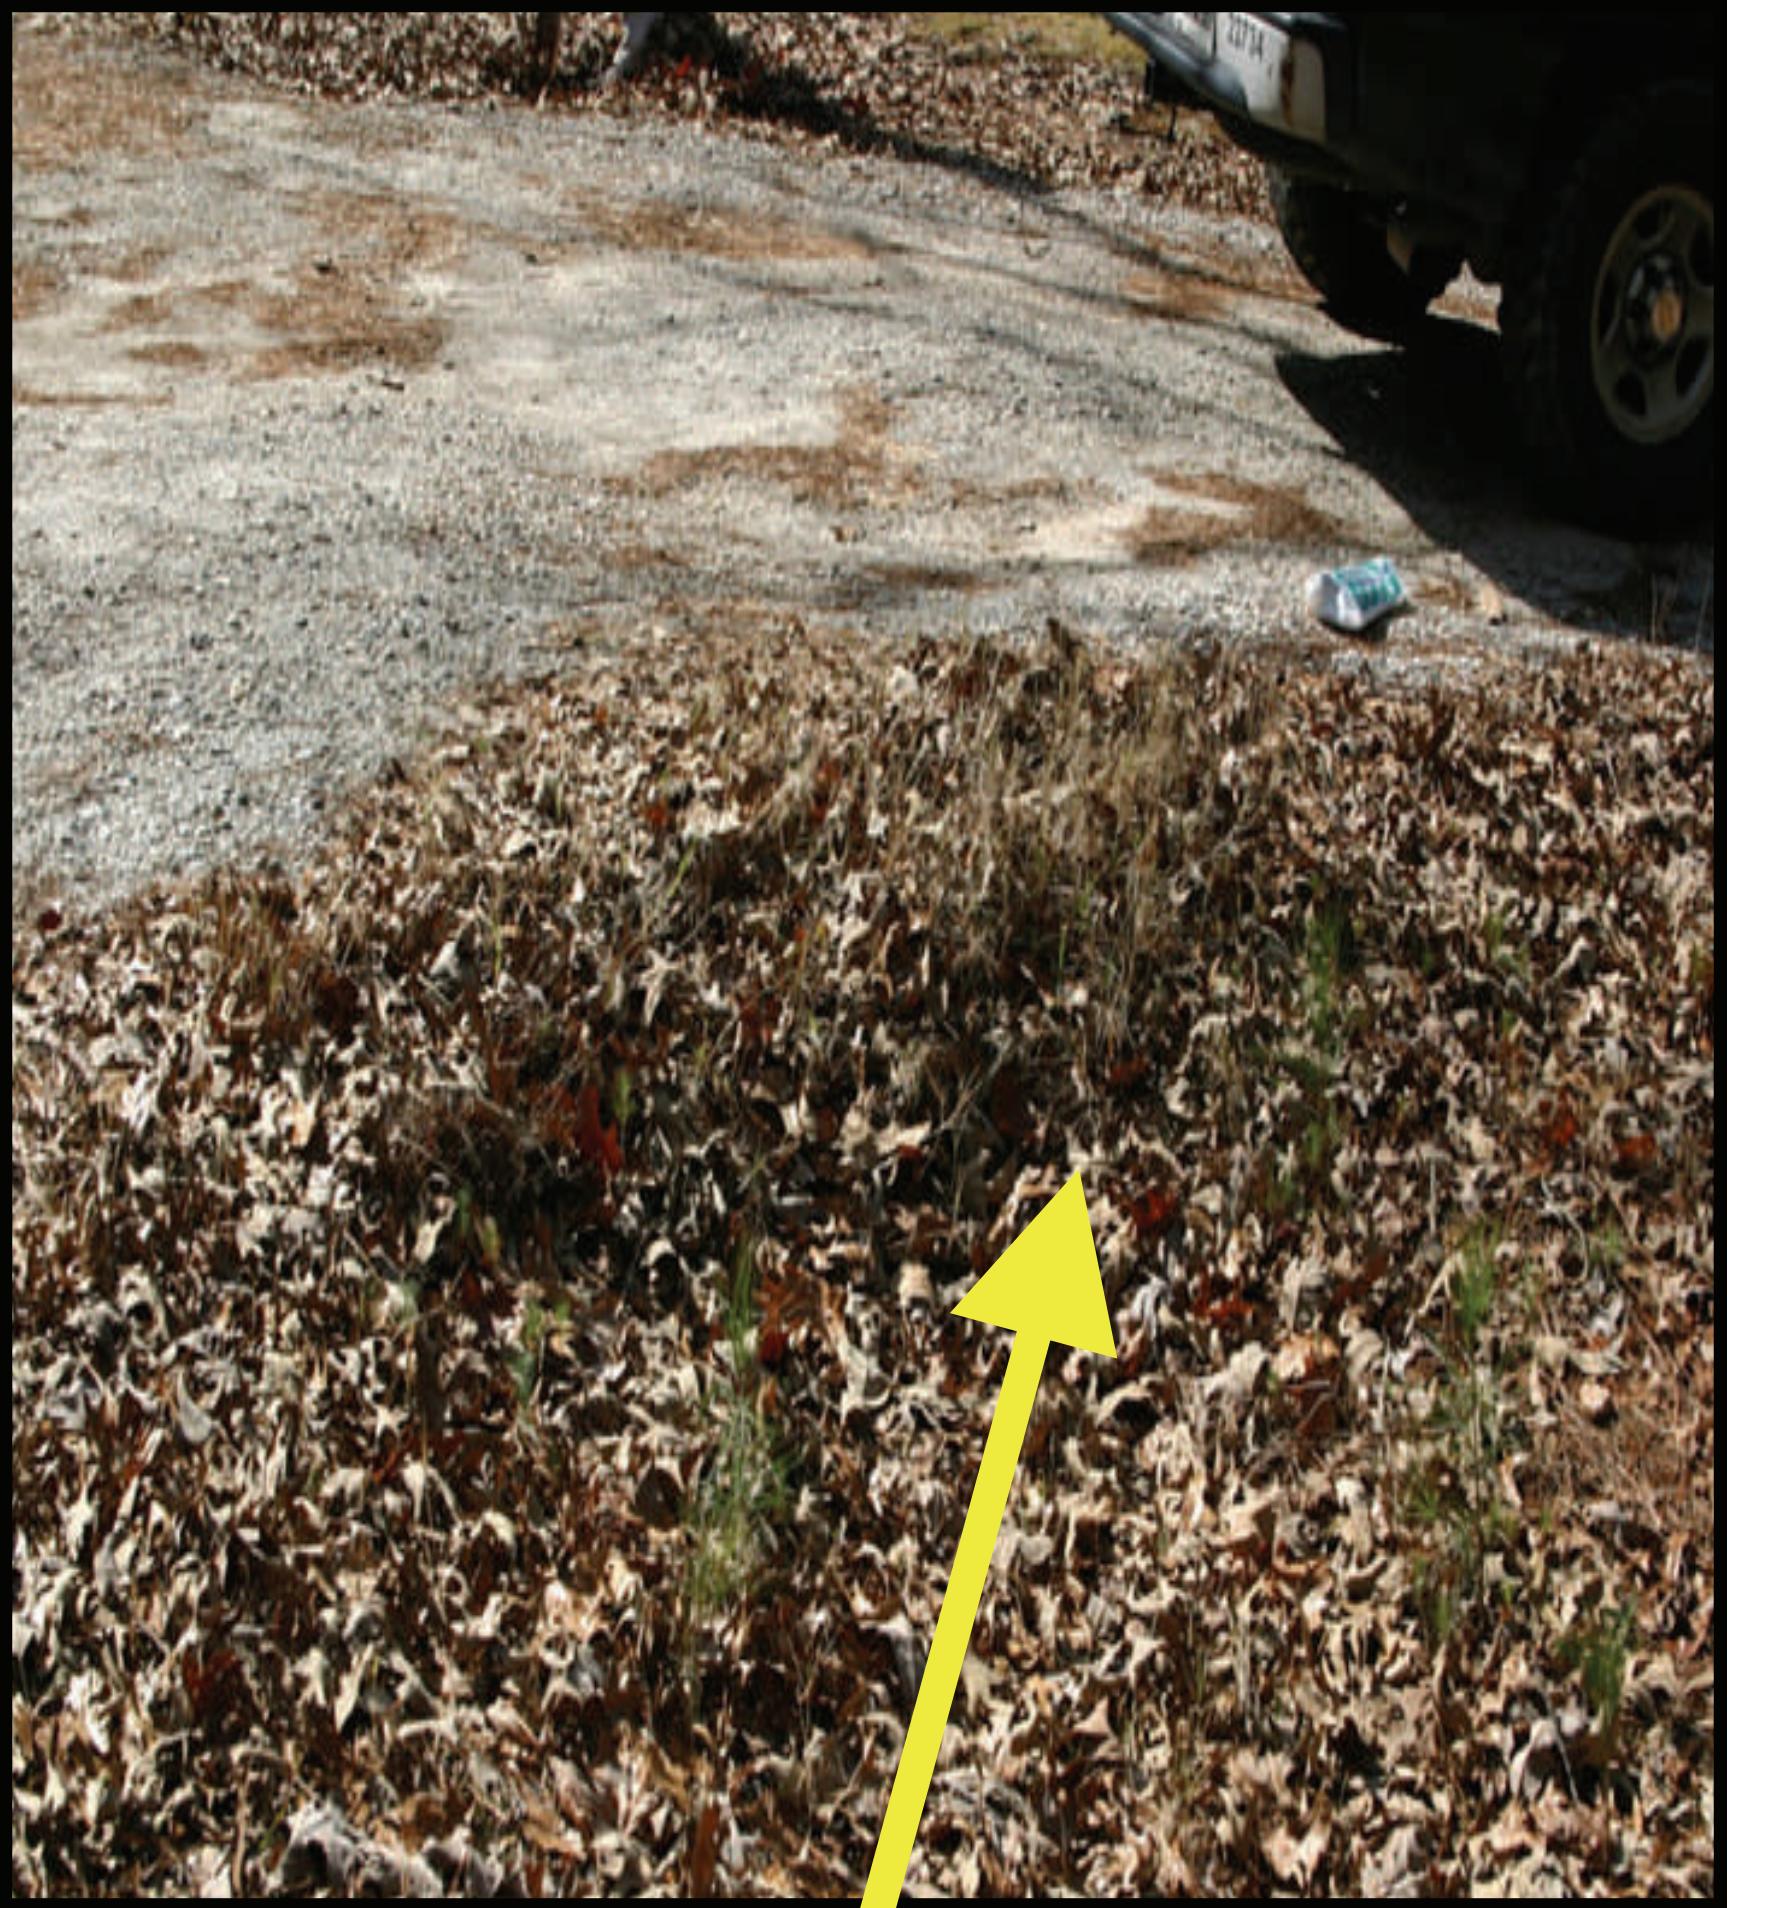
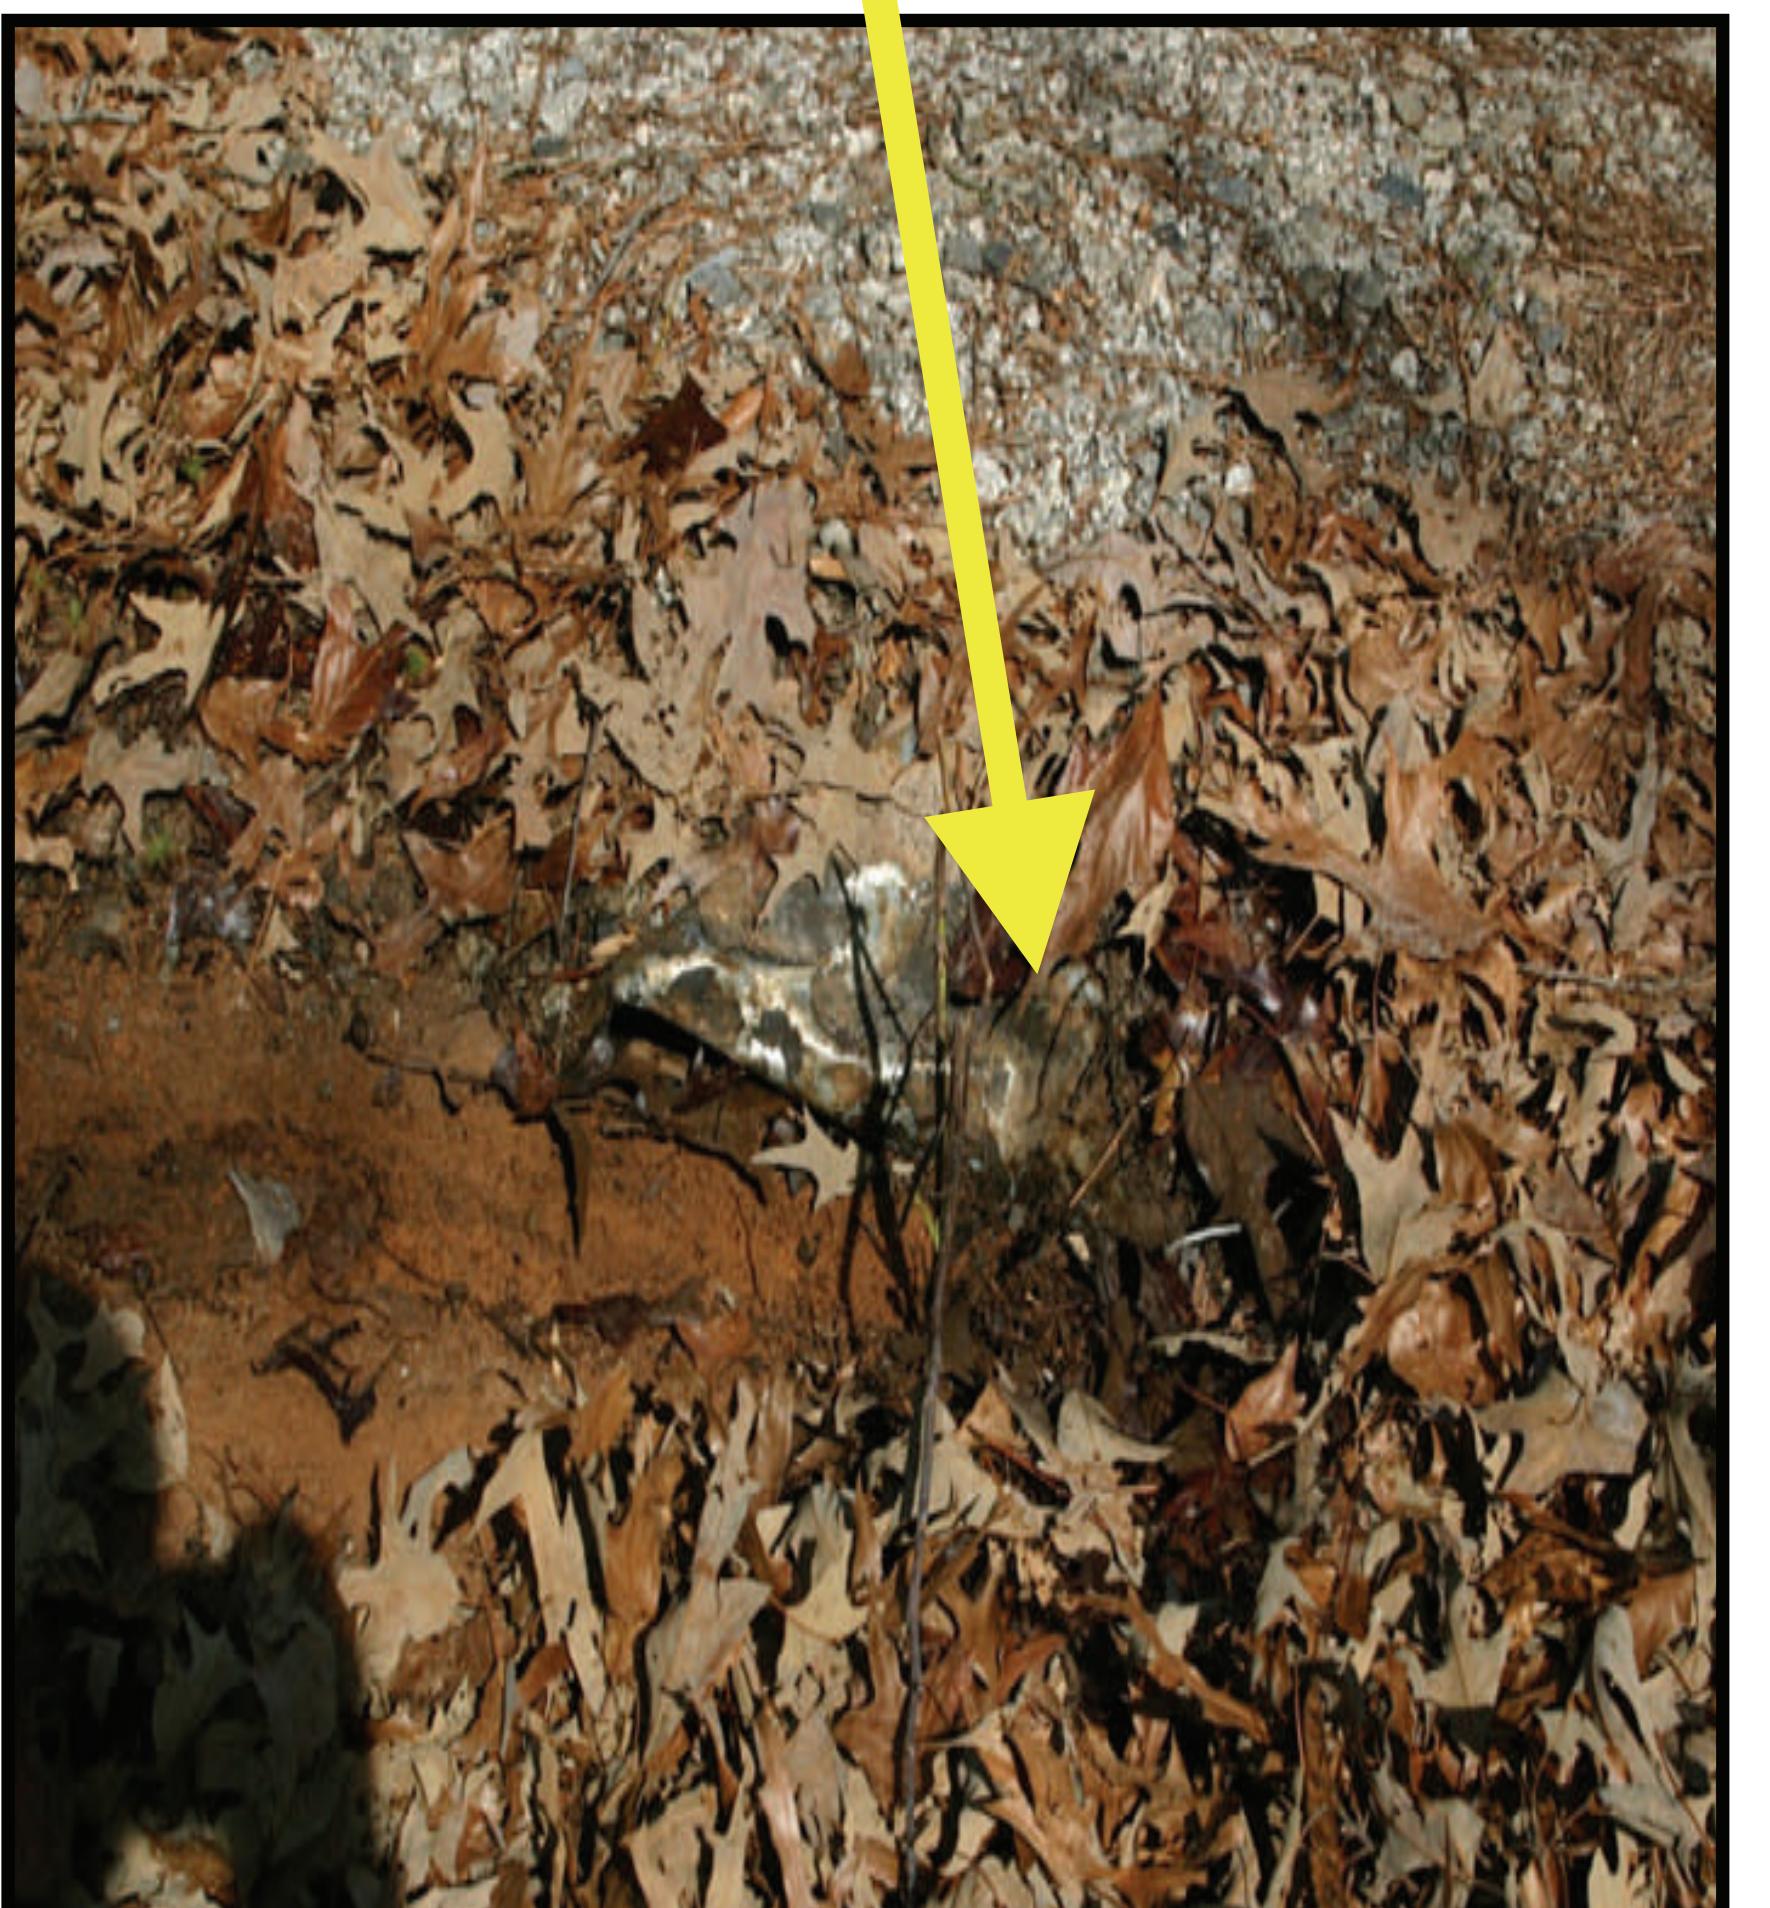
CLOGGED CULVERT

- One end of the driveway culvert is crushed and the other end is plugged by debris not allowing proper drainage.
- Stormwater runoff would be lessened if more gravel were placed on the bare driveway.
- If neighbor's grass, immediate left, was allowed to grow taller runoff velocity from the adjacent pasture would be greatly reduced.

• The county will attempt to open the crushed end and clean out debris inside the culvert.

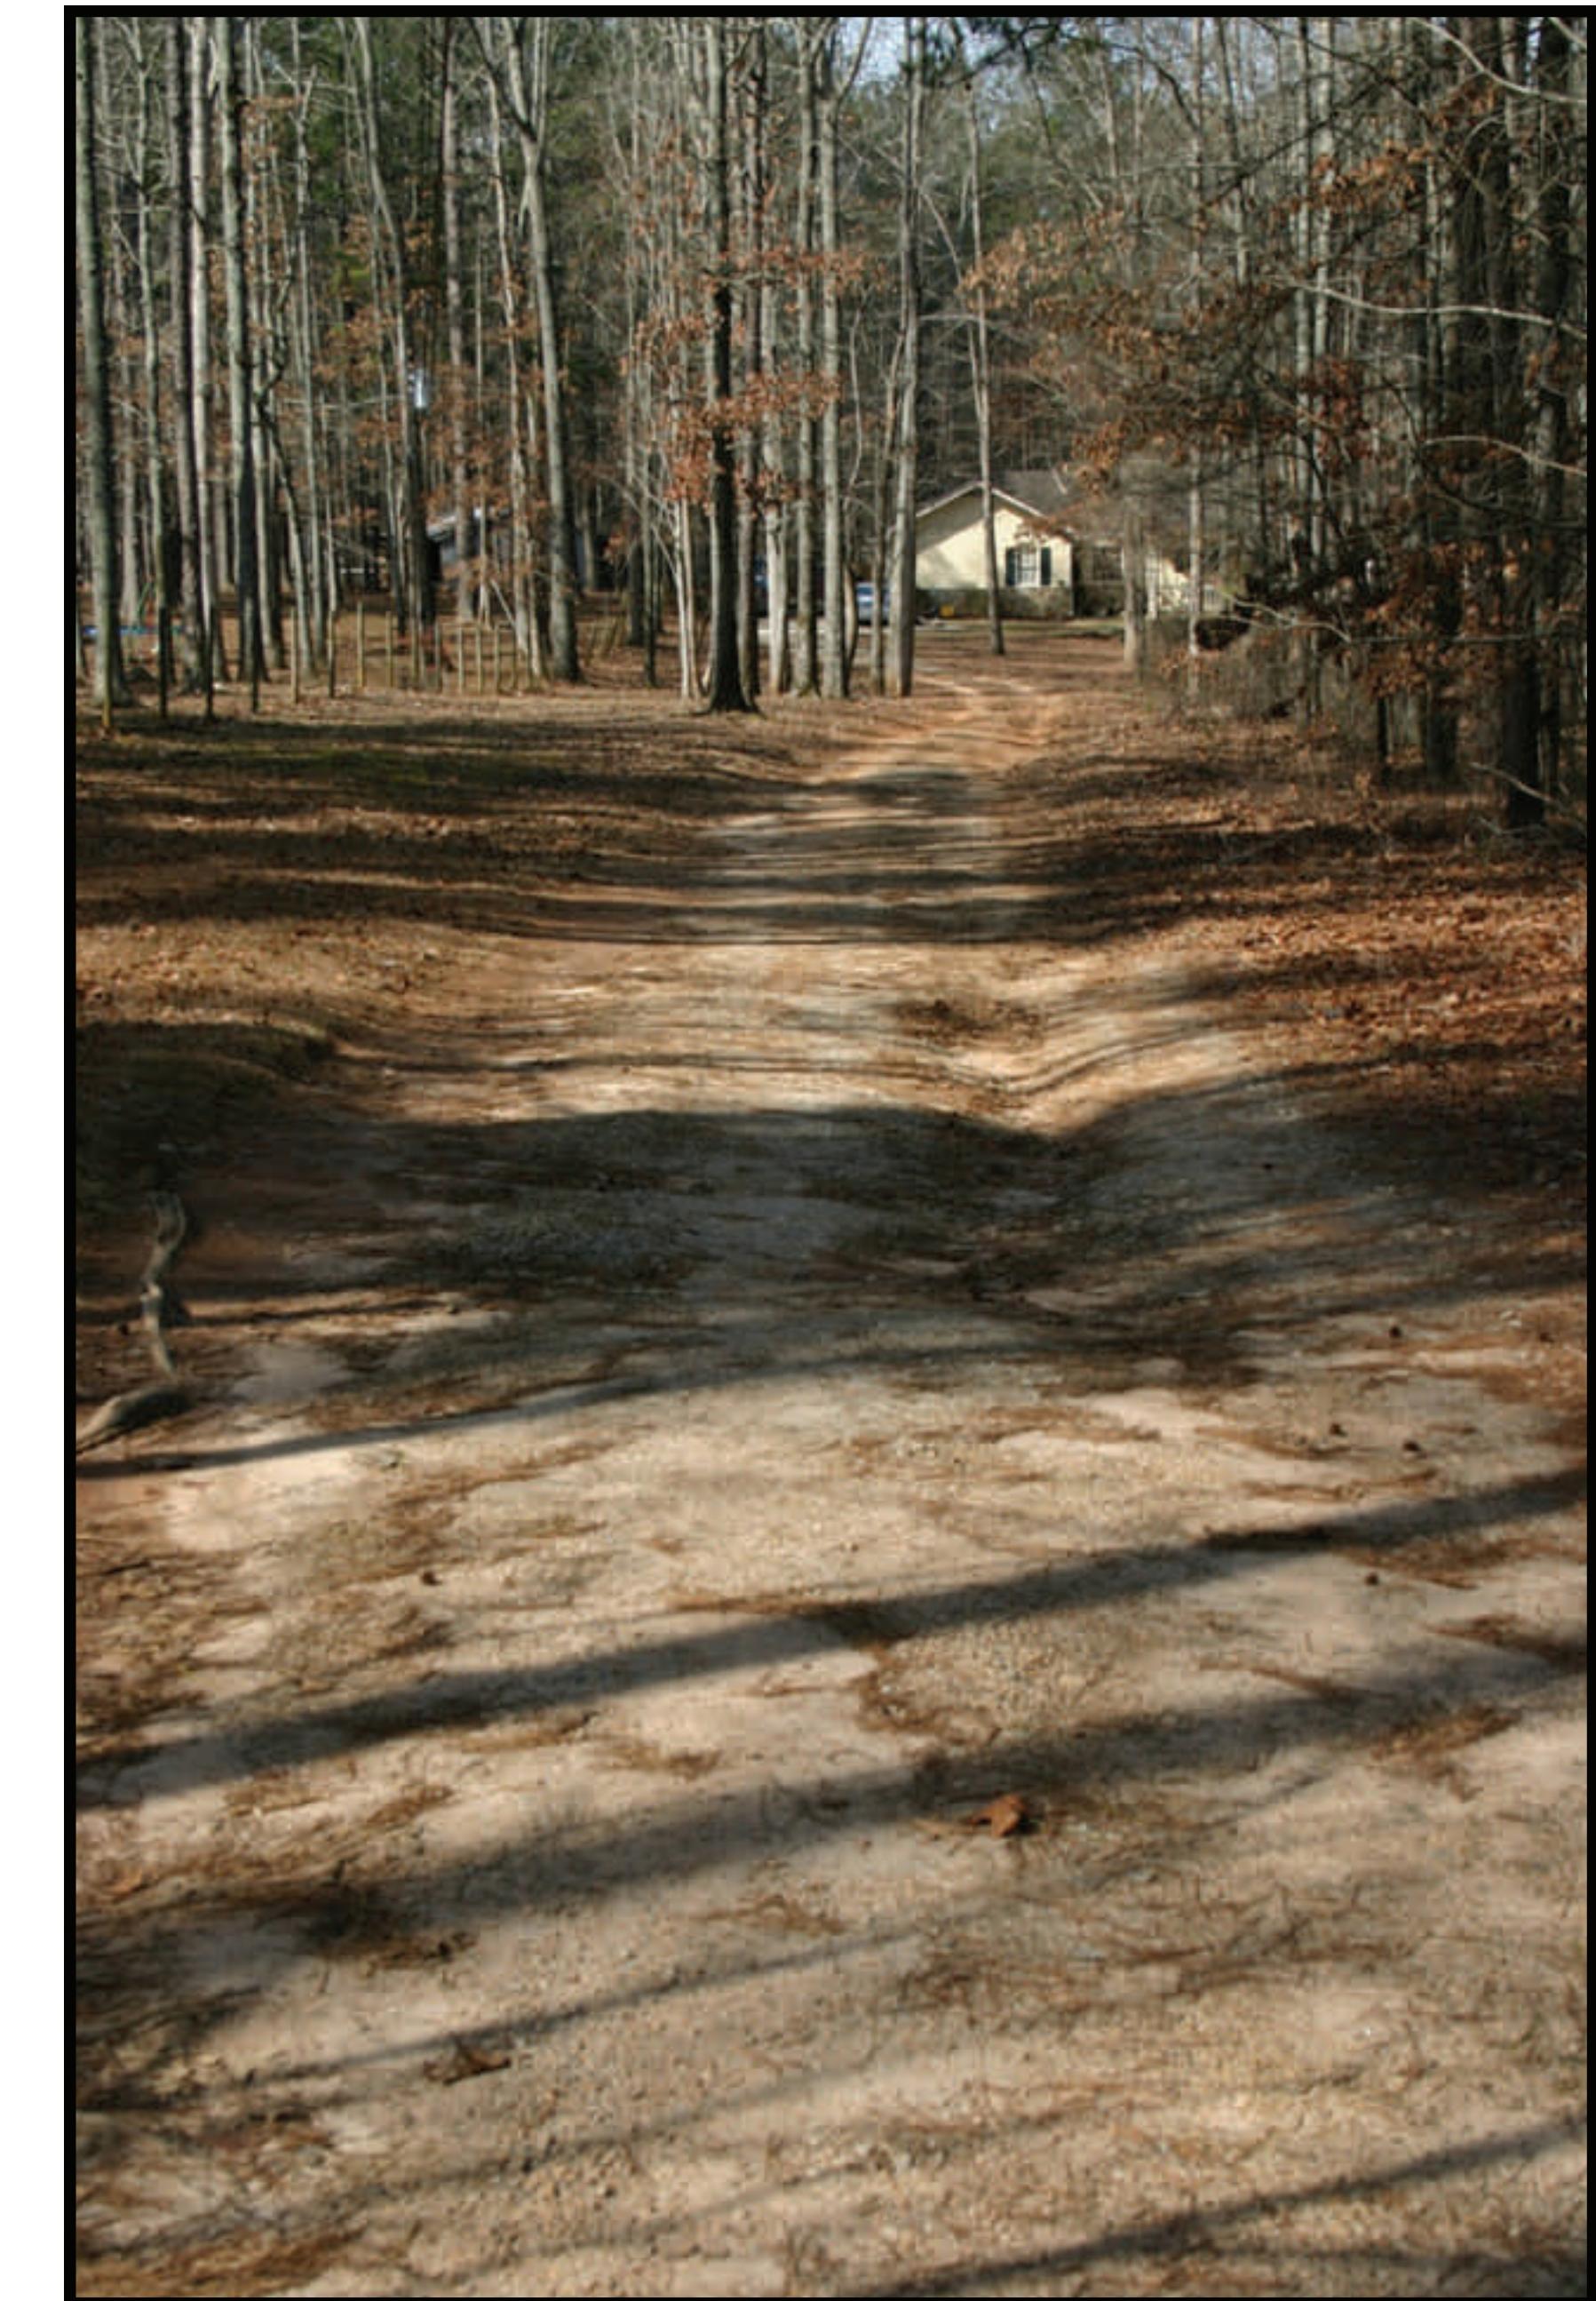
# 178 MILAM ROAD

- An open culvert allows stormwater to flow from beneath road to adjacent property.
- The out-flow area is stable with a significant amount of vegetation and no erosion.
- The water then flows to the rear of property where weaker soils are eroding away causing deep channels to form.

- We suggested to that he install some riprap (large stone) in the channels to slow the water down and prevent further erosion.
- We will have a crew excavate and rework drainage in the right-of-way for better drainage.

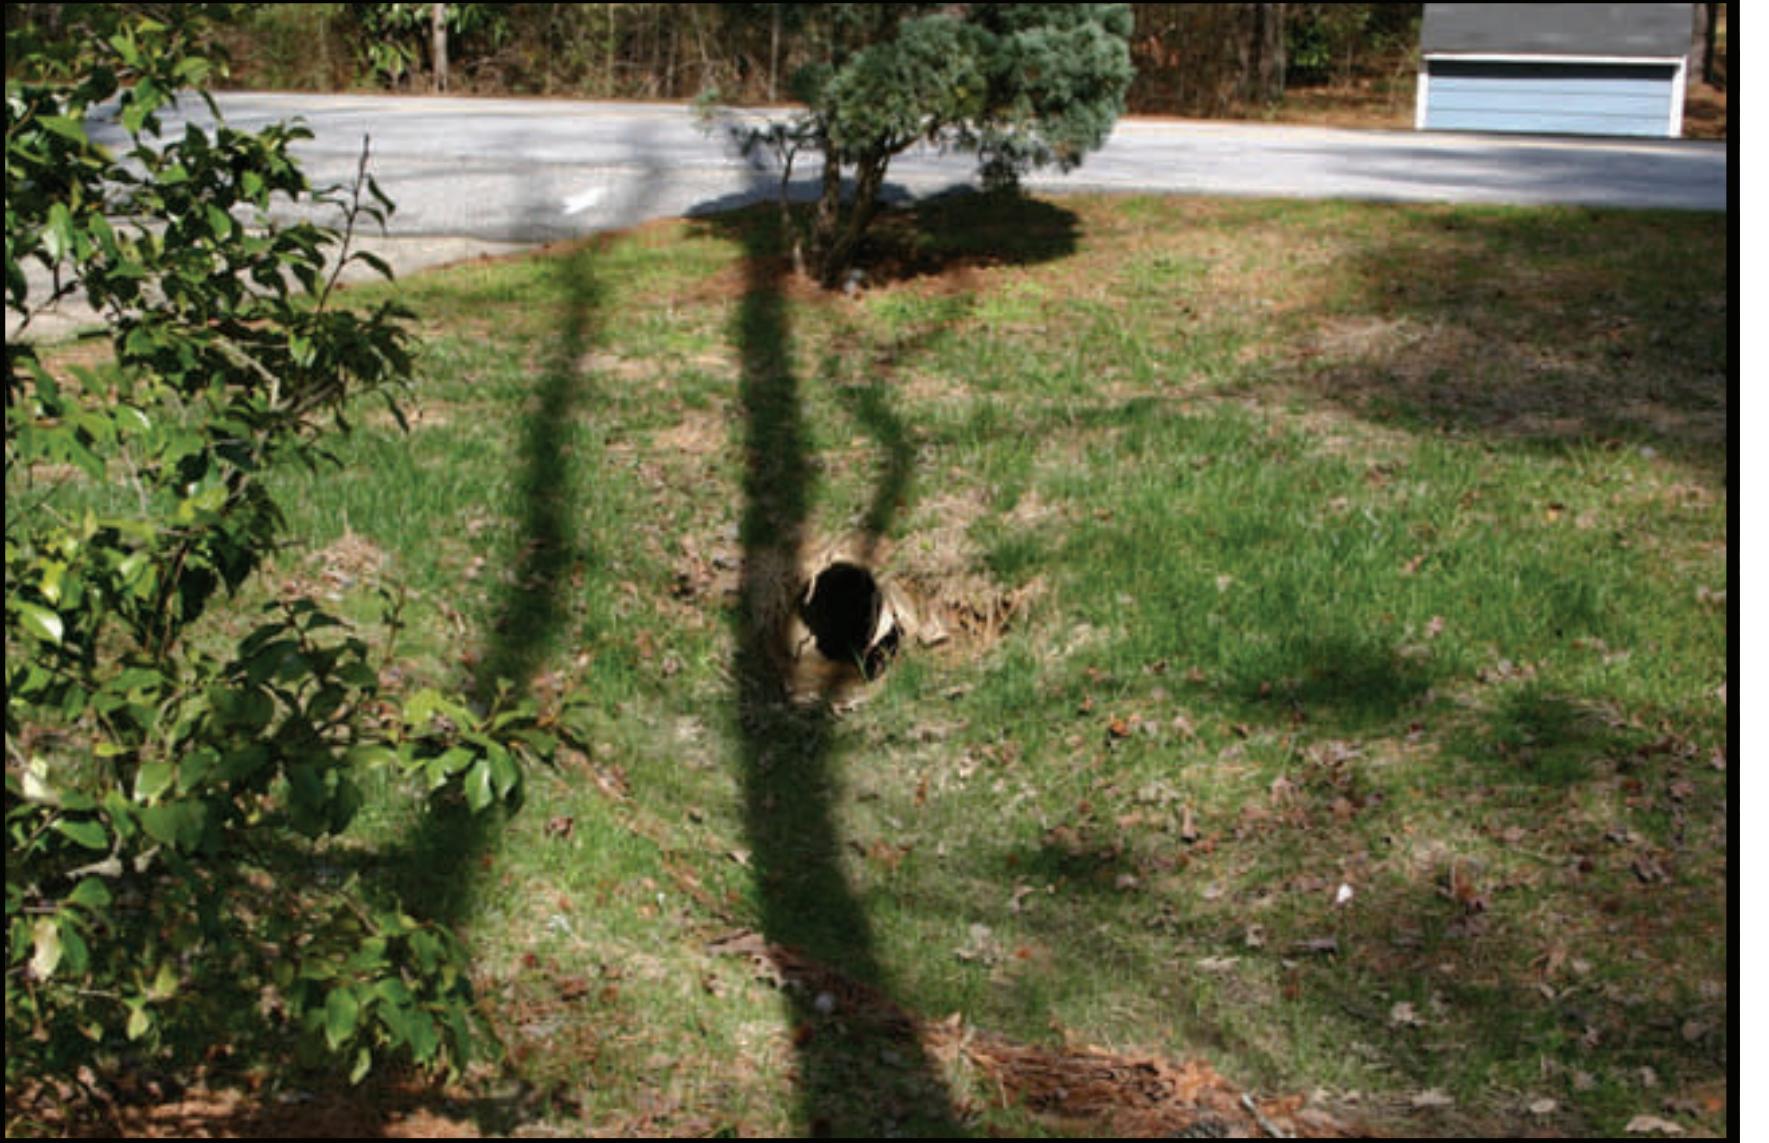
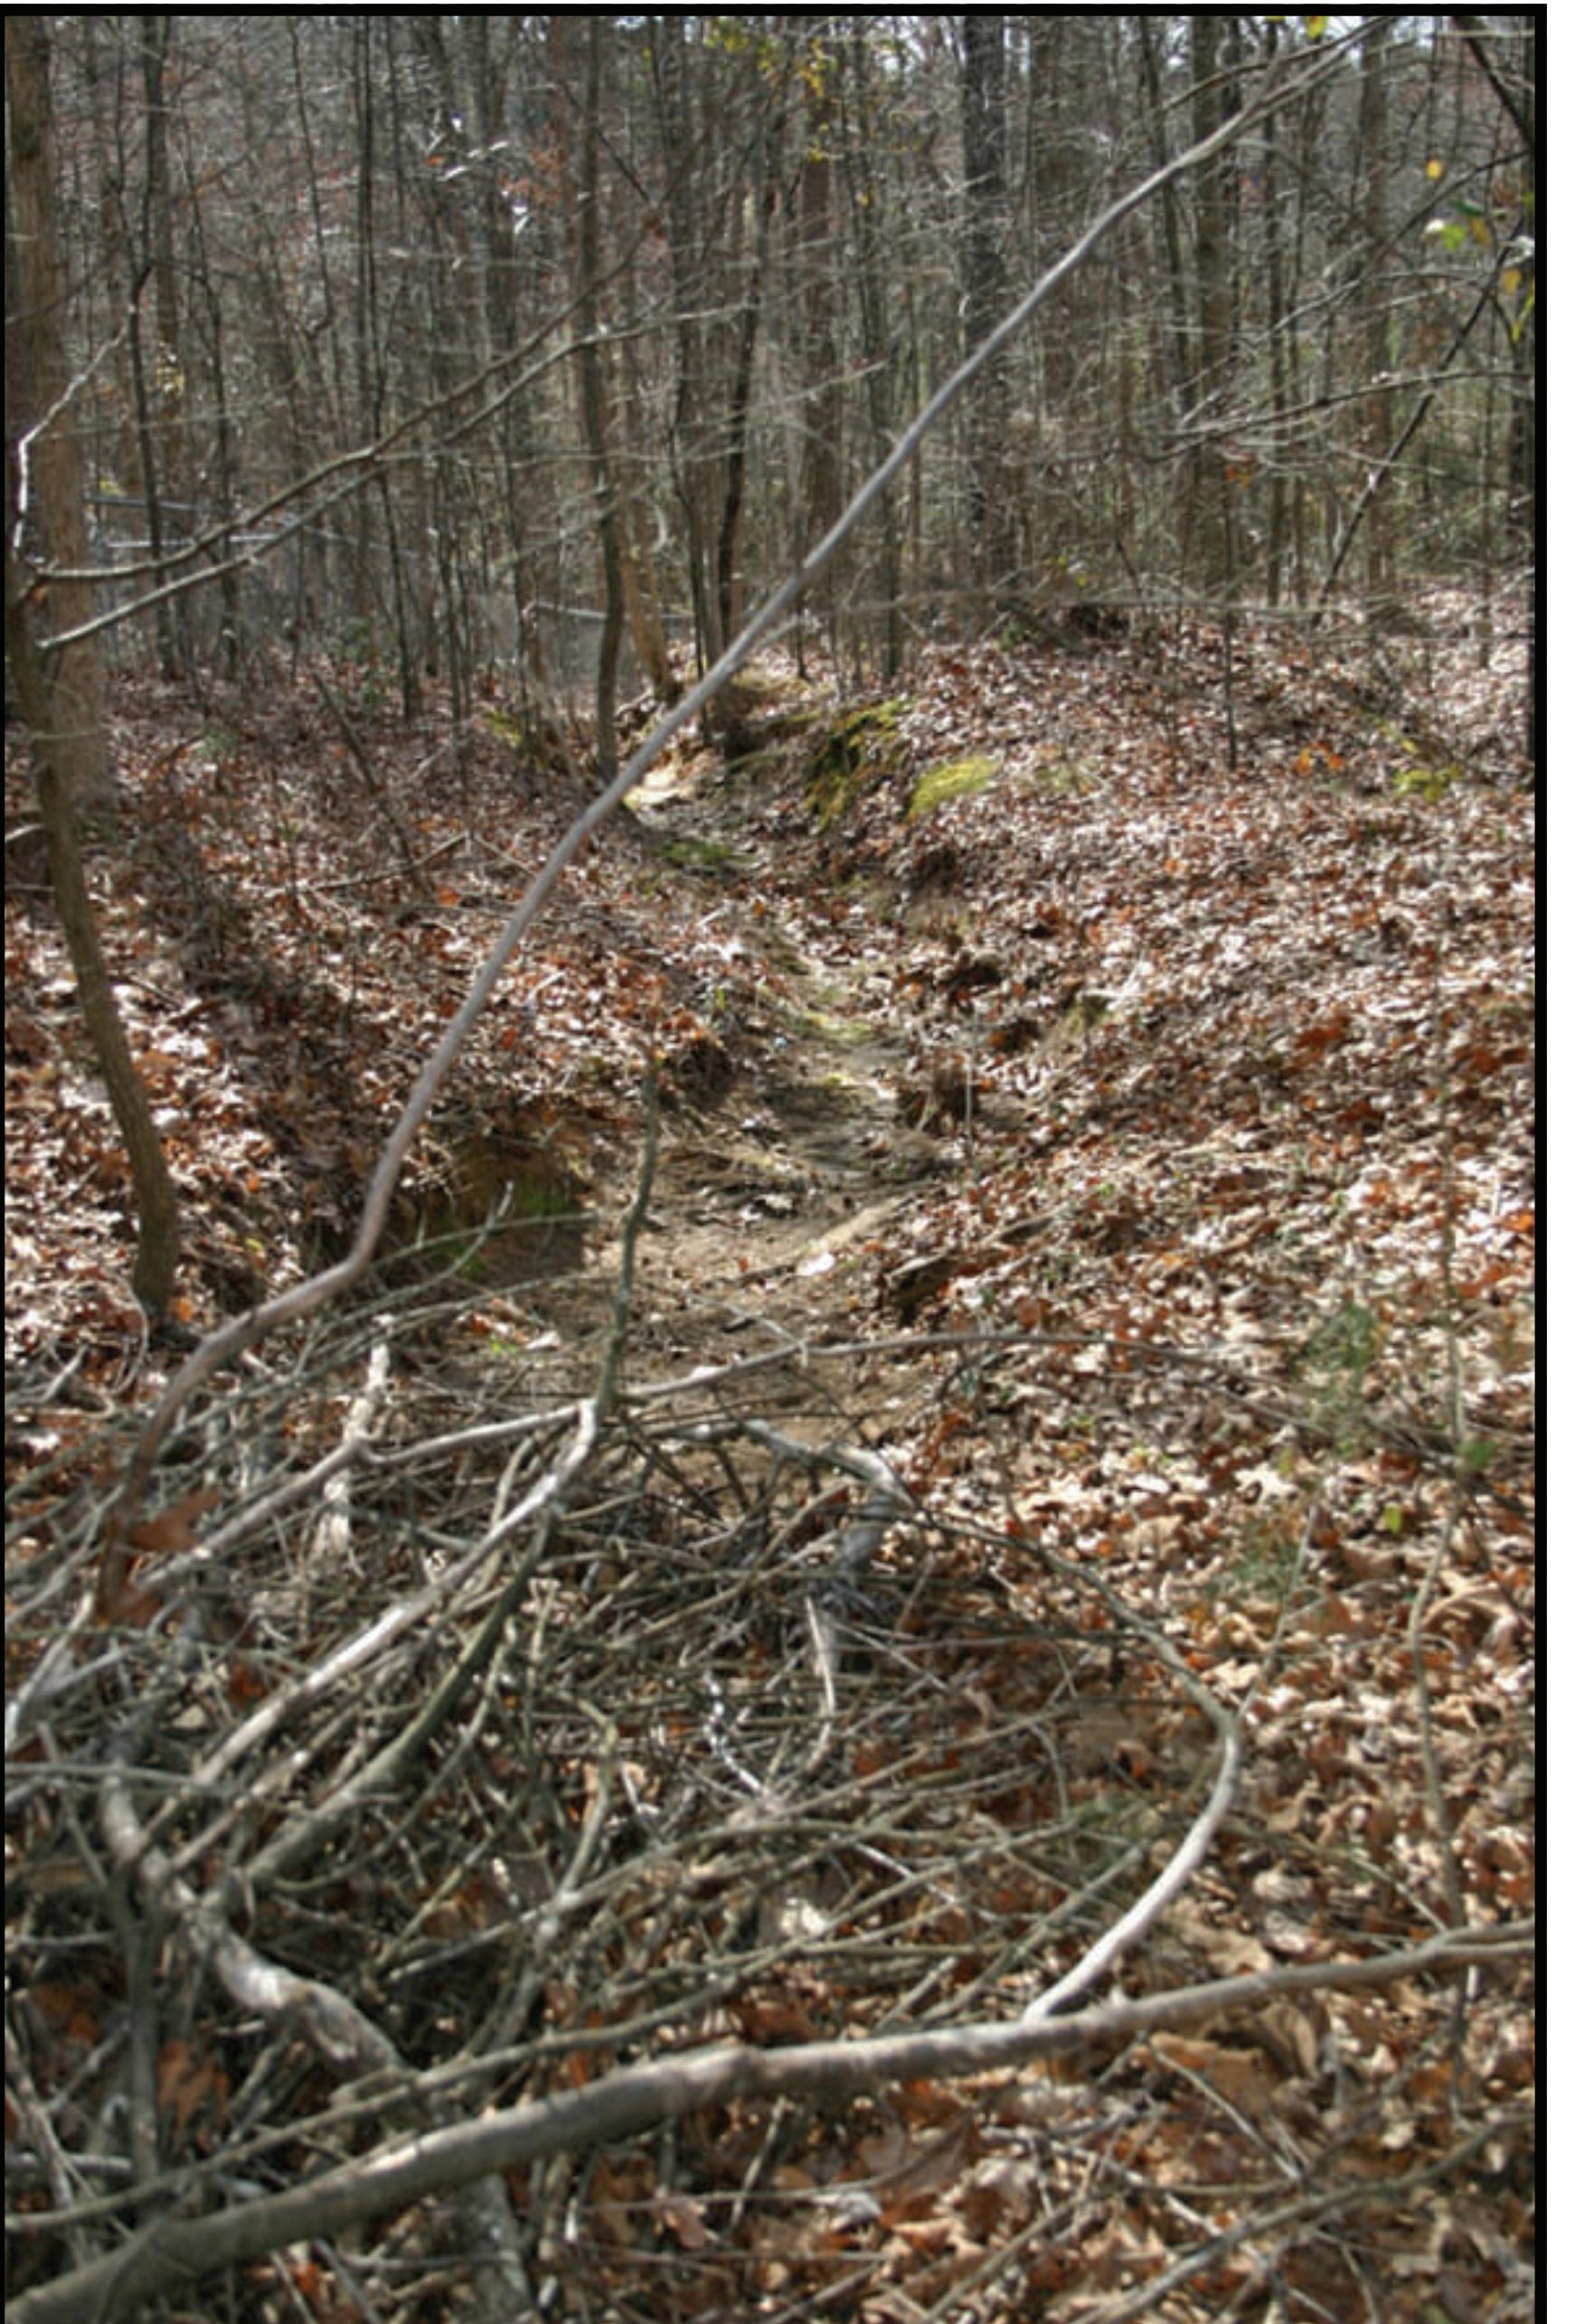
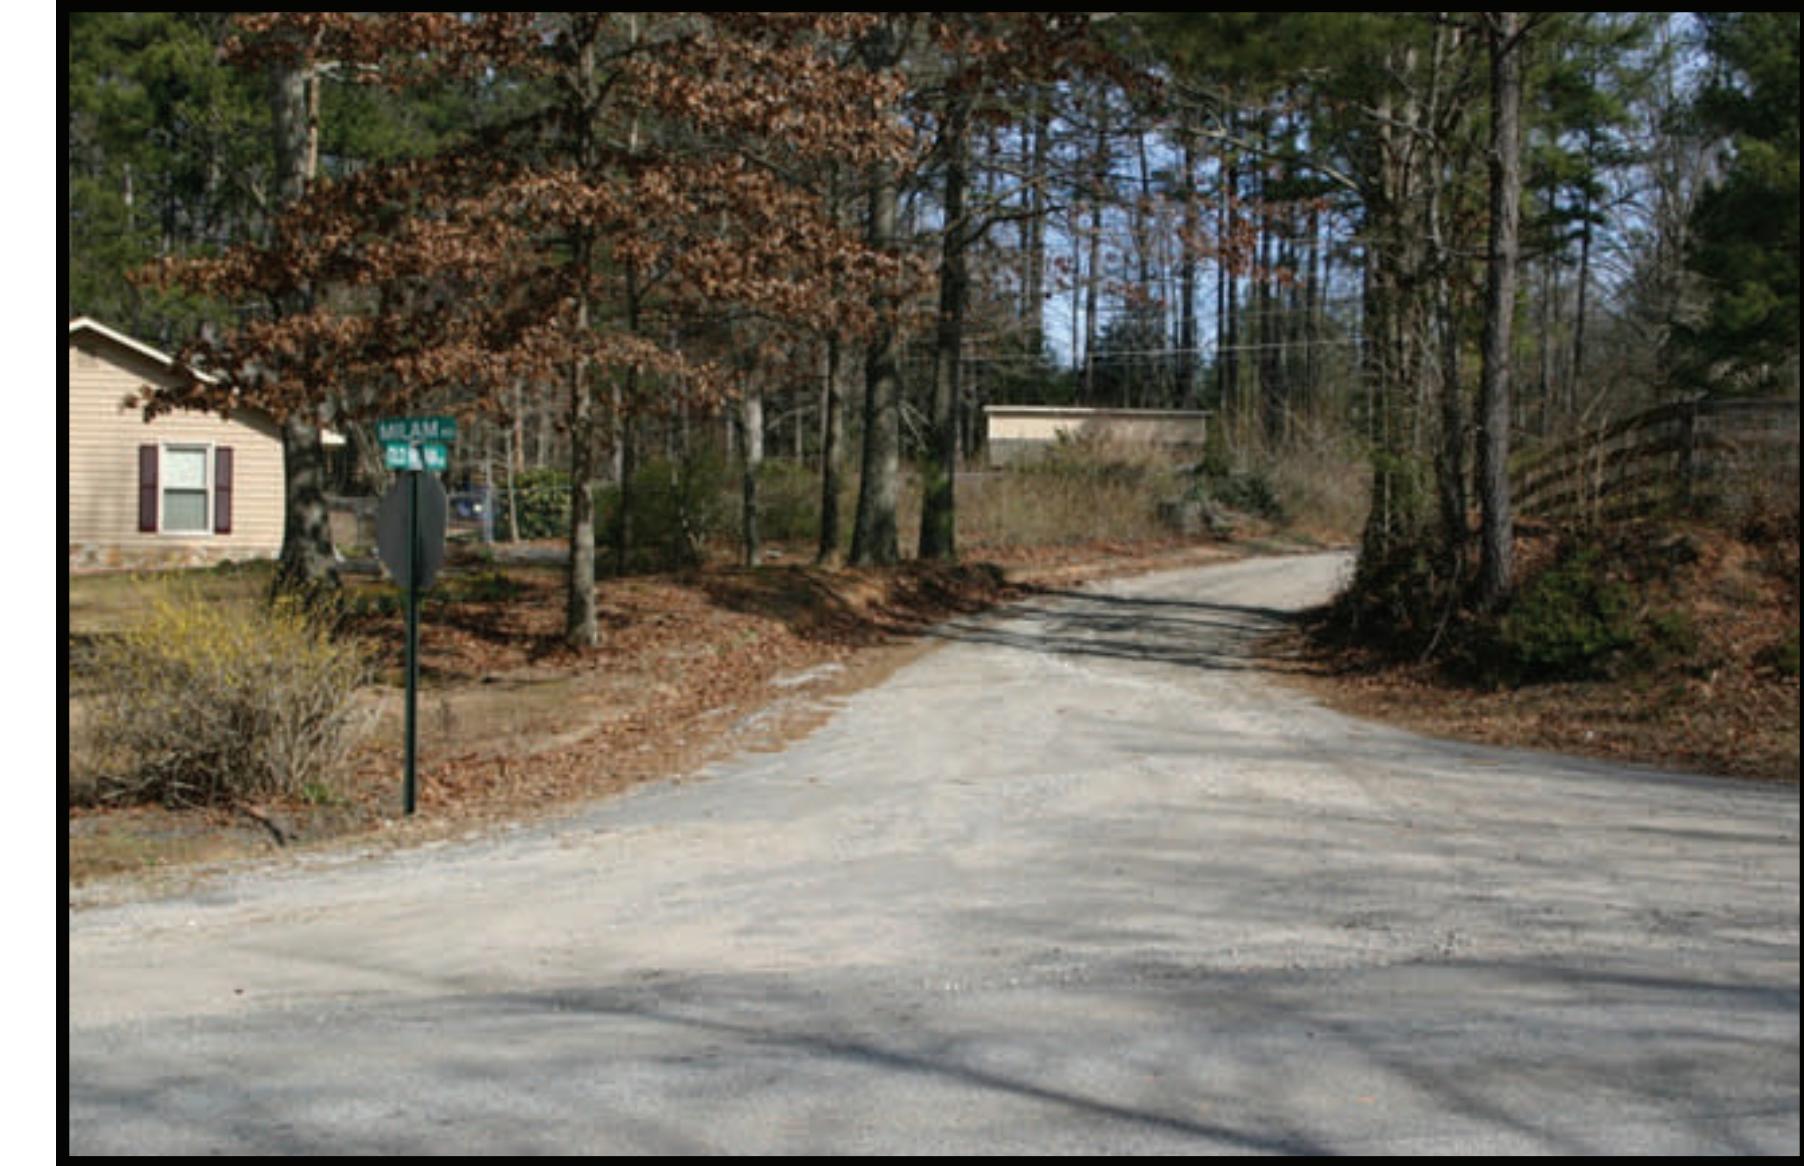
## ACROSS THE STREET

Stormwater washes out the gravel road onto the property to the left. Debris drifts to the home site and clogs the drainage ditch.
